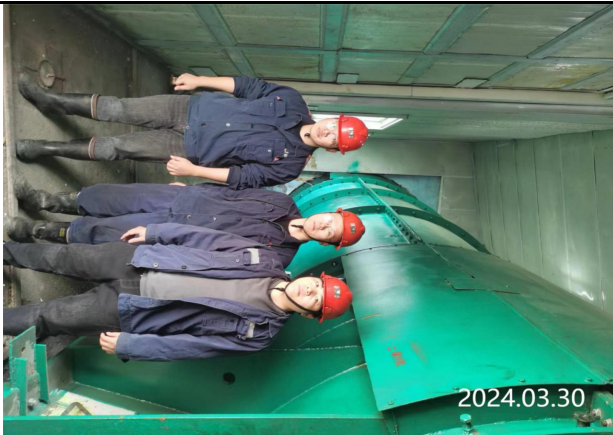
| 序号 | 报告编号 | 发布日期 | 结论 | 影像资料 |
|---|---|---|---|---|
| 1 | GX-B1340/23-9-24012 | 2024. 5. 6 | 东风井2#主要通风机系统合格。 | <p>2024.03.30</p> |

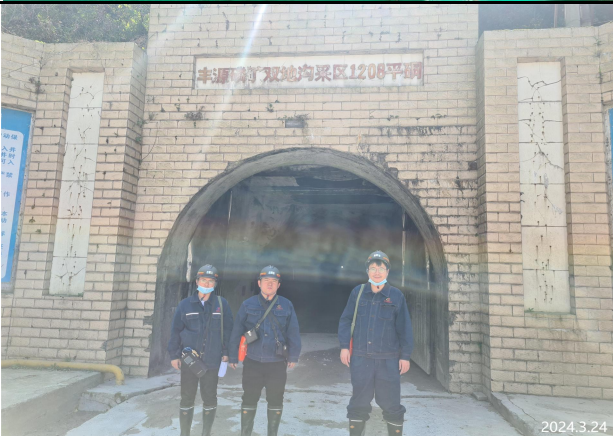
| 序号 | 报告编号 | 发布日期 | 结论 | 影像资料 |
|---|---|---|---|---|
| 2 | GX-B1343/21-9-24014 | 2024.5.7 | 1. 矿井总进风量：<br>1973.5m <sup>3</sup> /min，总回风量：<br>1983.4m <sup>3</sup> /min；<br>2. 主通风机风量：<br>2050.9m <sup>3</sup> /min；<br>3. 矿井有效风量：<br>1435.8m <sup>3</sup> /min；<br>4. 矿井有效风量率：<br>70.0%；<br>5. 通风机负压：588Pa；<br>6. 矿井通风阻力：<br>554.5Pa； | <p>2024.3.24</p> |

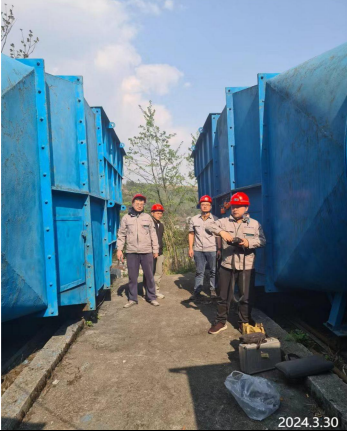
| 3 | GX-B1340/23-9-24010 | 2024.5.7 | 1#主要通风机系统合格。<br>。 | |

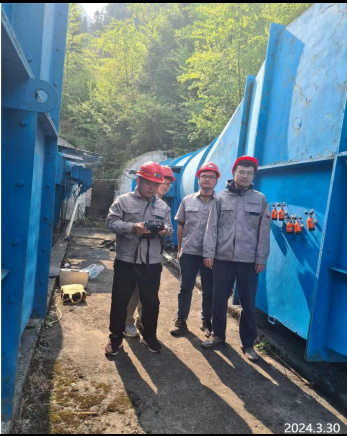
| 4 | GX-B1340/23-9-24011 | 2024.5.7 | 2#主要通风机系统合格。<br>。 | |

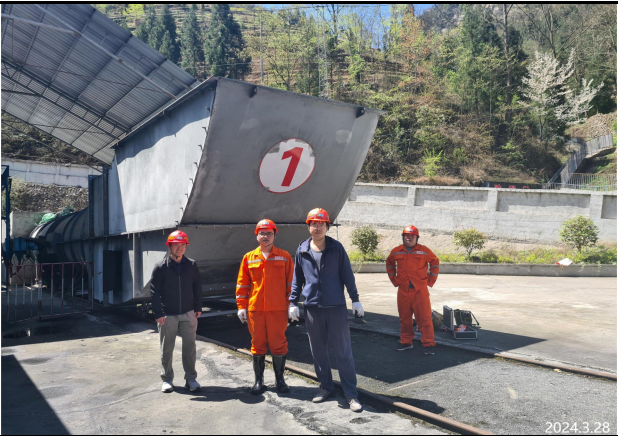
| 5 | GX-B1340/23-9-24013 | 2024.5.7 | 1#主要通风机系统合格。<br>。 | |

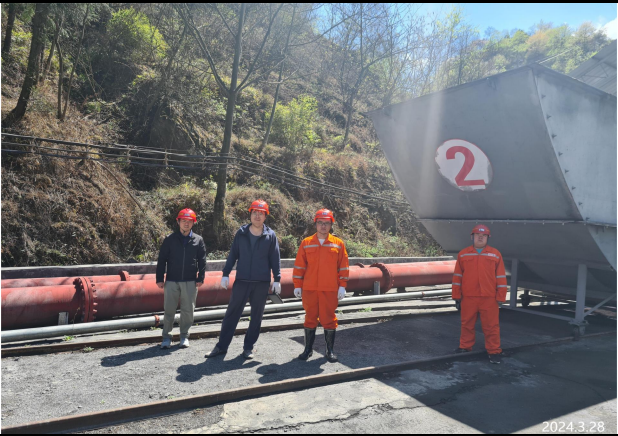
| 6 | GX-B1340/23-9-24014 | 2024.5.7 | 2#主要通风机系统合格。<br>。 | |

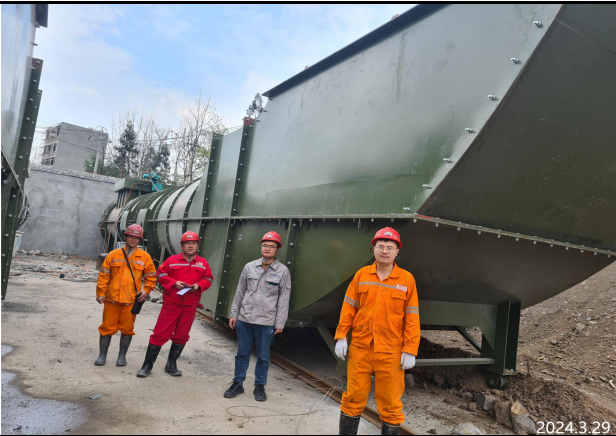
| 7 | GX-B1340/23-9-24015 | 2024.5.7 | 1#主要通风机系统合格。<br>。 | A photograph showing four workers in safety gear (orange and red jumpsuits, hard hats) standing in front of a large, green, industrial fan system. The fan is mounted on a concrete base. The date '2024.3.29' is visible in the bottom right corner of the photo. |

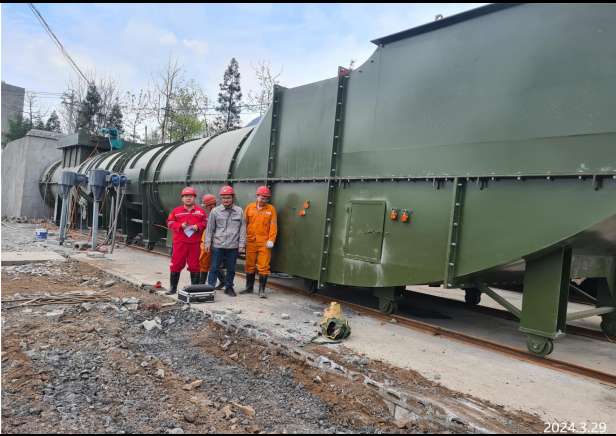
| 8 | GX-B1340/23-9-24016 | 2024.5.7 | 2#主要通风机系统合格。<br>。 | A photograph showing four workers in safety gear (orange and red jumpsuits, hard hats) standing in front of a large, green, industrial fan system. The fan is mounted on a concrete base. The date '2024.3.29' is visible in the bottom right corner of the photo. |

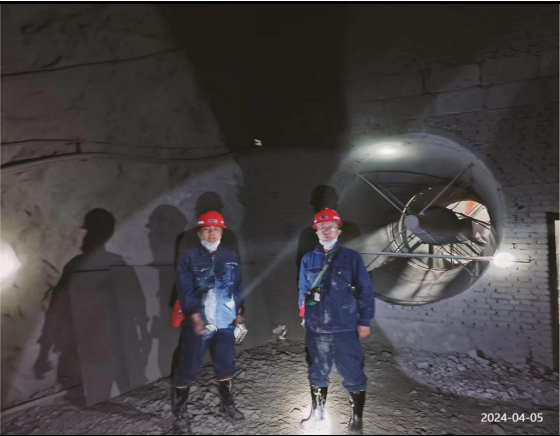
| 9 | GX-B1341/21-9-24094 | 2024.5.8 | 综合判定：合格。 | |

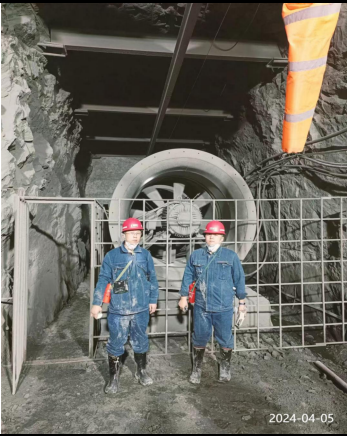
| 10 | GX-B1341/21-9-24095 | 2024.5.8 | 综合判定：合格。 | |

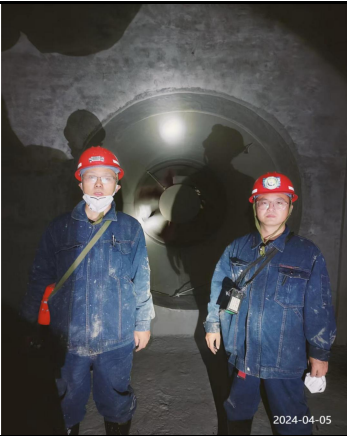
| 11 | GX-B1341/21-9-24096 | 2024.5.8 | 综合判定：合格。 | | <p>2024-04-05</p> | |

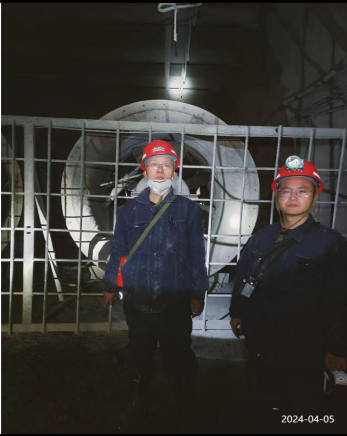
| 12 | GX-B1341/21-9-24097 | 2024.5.8 | 综合判定：合格。 | | <p>2024-04-05</p> | |

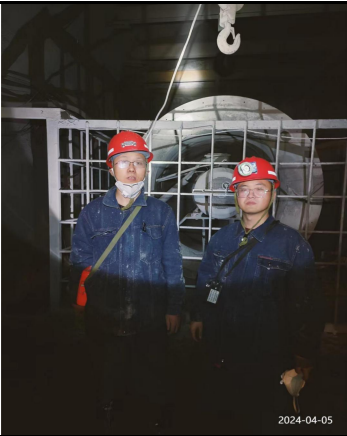
| 13 | GX-B1341/21-9-24098 | 2024.5.8 | 综合判定：合格。 | | <p>2024-04-05</p> |

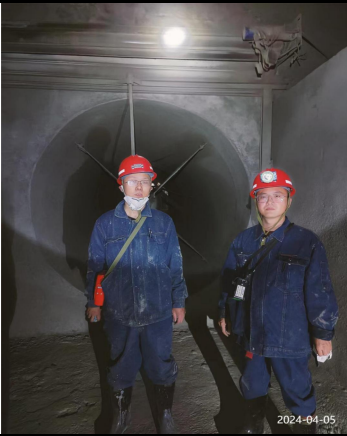
| 14 | GX-B1341/21-9-24099 | 2024.5.8 | 综合判定：合格。 | | <p>2024-04-05</p> |

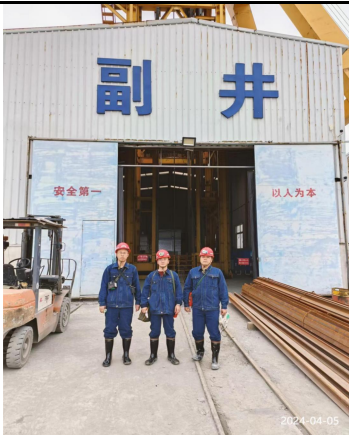
| 15 | GX-B1425/23-9-24006 | | <div>1. 矿井正常通风风量：<br/>11338.8m<sup>3</sup>/min；<br/>2. 矿井反风风量：7209.2m<sup>3</sup>/min；<br/>3. 机站正常通风风量：-300m中段主<br/>通风机为5307.1m<sup>3</sup>/min，-400m中段<br/>风机组为9795.2m<sup>3</sup>/min；<br/>4. 机站反风风量：-300m中段主通风<br/>机为3810.2m<sup>3</sup>/min，-400m中段风机<br/>组为7082.7m<sup>3</sup>/min；<br/>5. 机站反风率：-300m中段主通风机<br/>为71.79%，-400m中段风机组为<br/>72.31%；<br/>6. 矿井风流反向用时：7分10秒。</div> | |

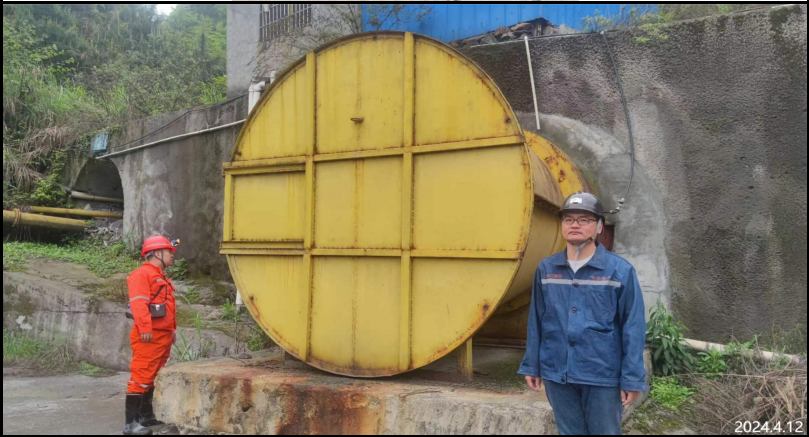
| 16 | GX-B1341/21-9-24100 | 2024.5.9 | 综合判定：合格。 | |

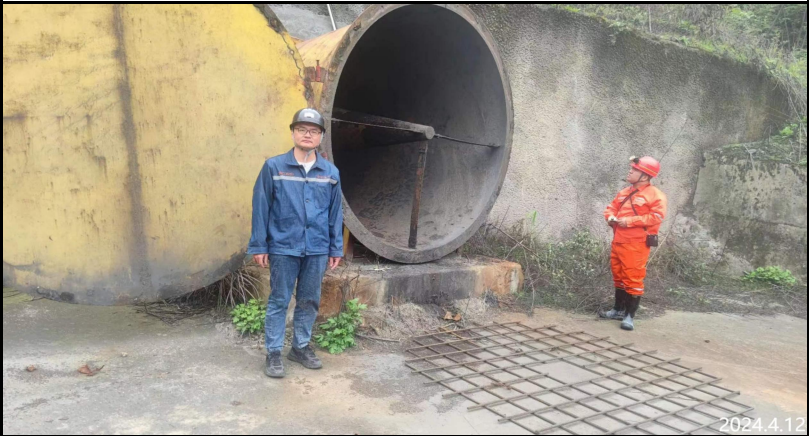
| 17 | GX-B1341/21-9-24101 | 2024.5.9 | 综合判定：合格。 | <p>2024.4.12</p> |

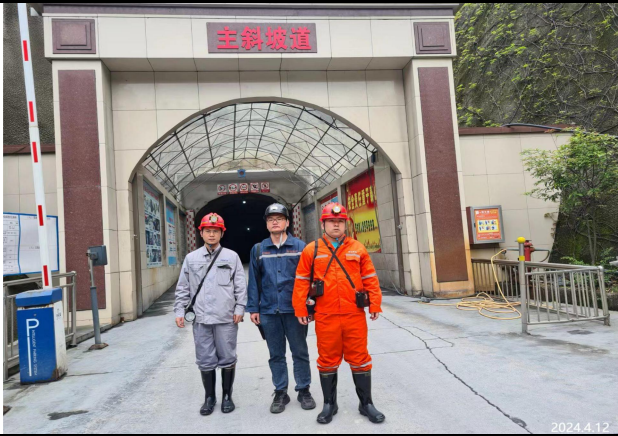
| 18 | GX-B1343/21-9-24017 | 2024.5.9 | <p>1. 矿井总进风量：3777.2m<sup>3</sup>/min，<br/>矿井总回风量：3842.7m<sup>3</sup>/min；</p> <p>2. 主通风机风量：3918.6m<sup>3</sup>/min；</p> <p>3. 矿井有效风量：2652.7m<sup>3</sup>/min；</p> <p>4. 矿井有效风量率：67.7%；</p> <p>5. 通风机负压：849Pa；</p> <p>6. 矿井通风阻力：774.2Pa。</p> | <p>2024.4.12</p> |

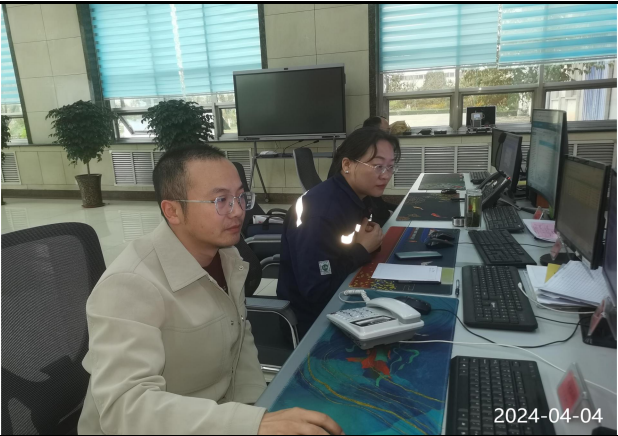
| 19 | GX-B1370/21-9-24006 | 2024. 5. 9 | <p>存在问题：</p> <p>1、监控系统传感器调校制度调校周期时间未及时更新；</p> <p>2、一氧化碳传感器调校记录中存在误差及报警栏未填写情况。</p> <p>建议：</p> <p>1、加强甲烷超限断电闭锁和故障闭锁功能维护。</p> <p>2、建议建立安全监控设备检修室，负责本矿安全监控设备的安装、调校、维护和简单维修工作。</p> <p>除上述问题外，其余所检项目合格。</p> | <p>2024-04-04</p> |

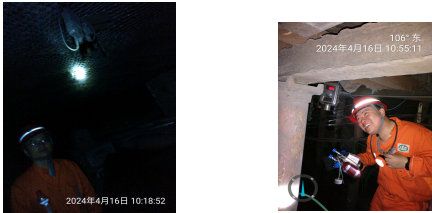
| 20 | GX-B1370/21-9-24004 | 2024年5月9日 | <p>存在问题：</p> <p>一氧化碳传感器调校记录表中标准气样填写错误。</p> <p>建议：加强传感器日常维护及调校。</p> <p>除上述问题外，其余所检项目合格。</p> | |
