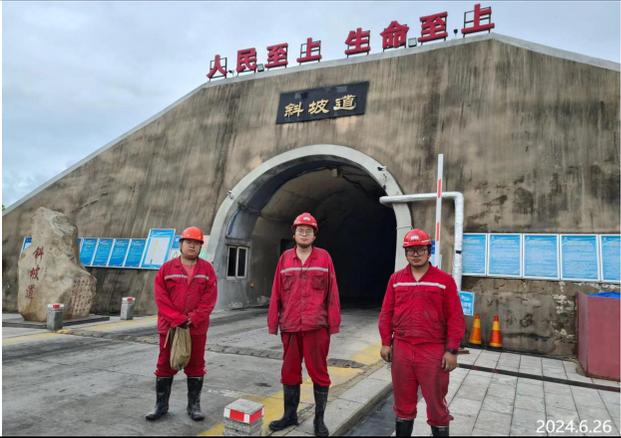
序号	报告编号	发布日期	结论	影像资料
51	GX-B1343/21-9-24036	2024. 7. 23	<ol style="list-style-type: none"> 1. 矿井总进风量：15074.5m³/min，矿井总回风量：15250.5m³/min； 2. 主通风机风量：15495.6m³/min； 3. 矿井有效风量：10310.0m³/min； 4. 矿井有效风量率：66.5%； 5. 机站风量：吴集-250m水平北风井通风机组8421.2m³/min；吴集-325m水平南风井通风机组7074.4m³/min； 6. 机站风压：吴集-250m水平北风井通风机组873Pa；吴集-325m水平南风井通风机组764Pa； 7. 矿井通风阻力：吴集北风井通风系统829.9Pa；吴集南风井通风系统741.5Pa。

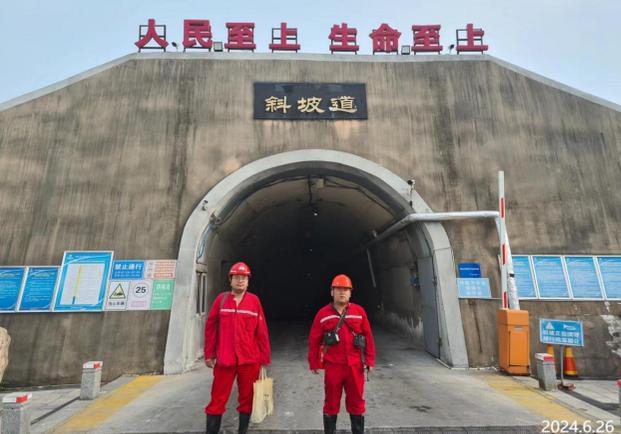
52	GX-B1347/21-9-24029	2024. 7. 23	<ol style="list-style-type: none"> 1. 风量（风速）合格率：100%，大于65%，合格； 2. 风质合格率：100%，大于90%，合格； 3. 作业环境空气质量合格率：100%，大于60%，合格； 4. 矿井有效风量率66.5%，大于60%，合格； 5. 风机全压效率平均值79.7%，大于70%，合格； 6. 风量供需比1.43，符合$1.32 \leq \beta \leq 1.67$要求，合格； 7. 综合指标90.0%，大于72%，合格。

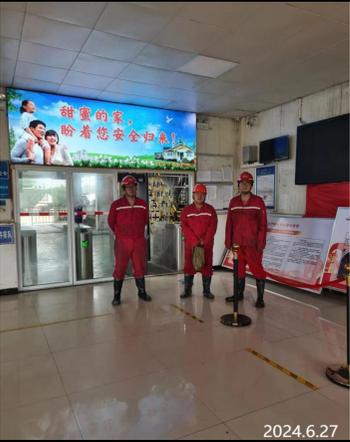
53	GX-B1343/21-9-24037	2024. 7. 23	<ol style="list-style-type: none"> 1. 矿井总进风量: 25034.6m³/min, 矿井总回风量: 25345.9m³/min; 2. 主通风机风量: 25774.9m³/min; 3. 矿井有效风量: 18297.7m³/min; 4. 矿井有效风量率: 71.0%; 5. 机站风量: 李楼北风井通风机组 14479.6m³/min; 24线南措施井主通风机 5795.7m³/min; 24线北措施井主通风机 5499.6m³/min; 6. 机站风压: 李楼北风井通风机组1728Pa; 24线南措施井主通风机1709Pa; 24线北措施井主通风机1102Pa; 7. 矿井通风阻力: 李楼北风井通风系统 1667.1Pa; 24线南措施井通风系统1643.3Pa; 24线北措施井通风系统1080.9Pa。

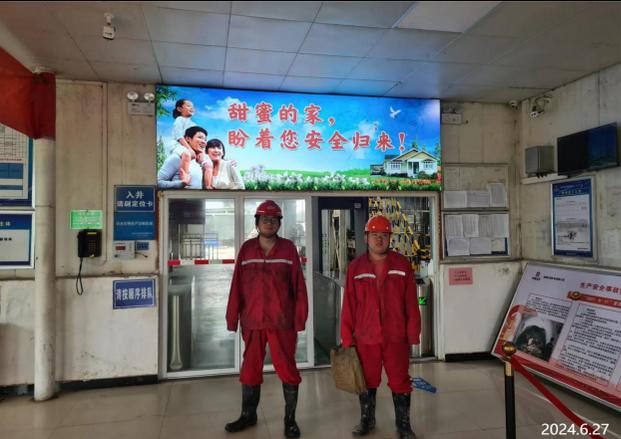
54	GX-B1347/21-9-24030	2024. 7. 23	<ol style="list-style-type: none"> 1. 风量（风速）合格率: 100%, 大于65%, 合格; 2. 风质合格率: 100%, 大于90%, 合格; 3. 作业环境空气质量合格率: 100%, 大于60%, 合格; 4. 矿井有效风量率71.0%, 大于60%, 合格; 5. 风机全压效率平均值72.2%, 大于70%, 合格; 6. 风量供需比1.43, 符合$1.32 \leq \beta \leq 1.67$要求, 合格; 7. 综合指标89.5%, 大于72%, 合格。

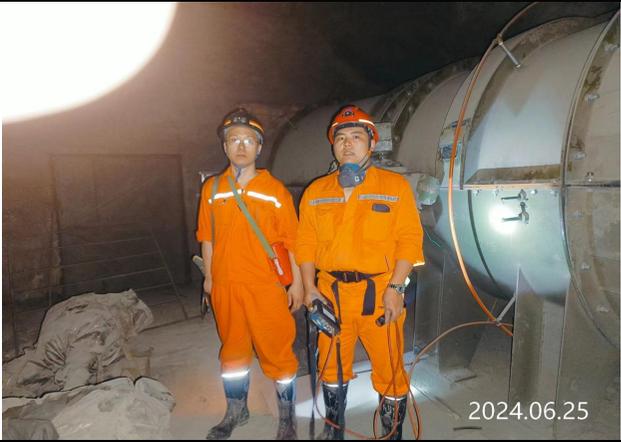
55	GX-B1341/24-9-24148	2024. 7. 23	综合判定：合格。

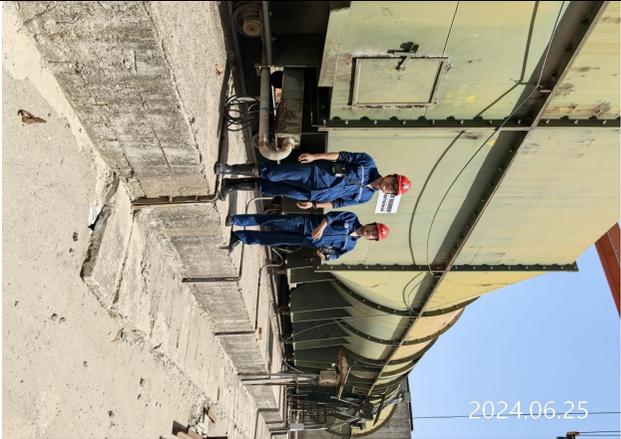
56	GX-B1341/24-9-24149	2024. 7. 23	综合判定：合格。

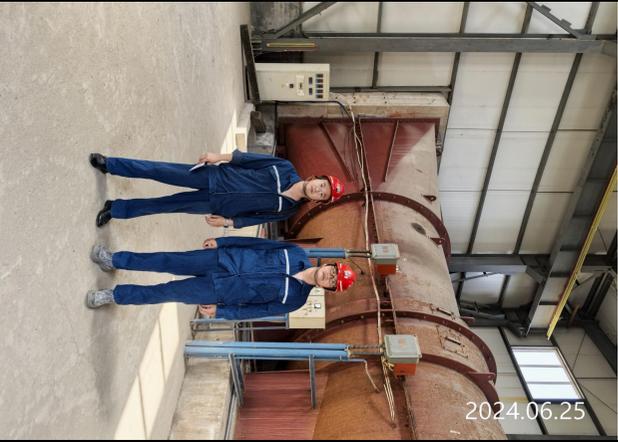
57	GX-B1341/24-9-24150	2024. 7. 23	综合判定：合格。

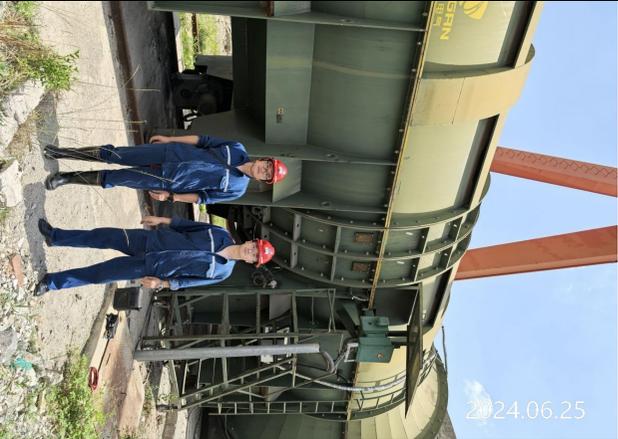
<p>2024.06.25</p>
58	GX-B1341/24-9-24151	2024. 7. 23	综合判定：合格。

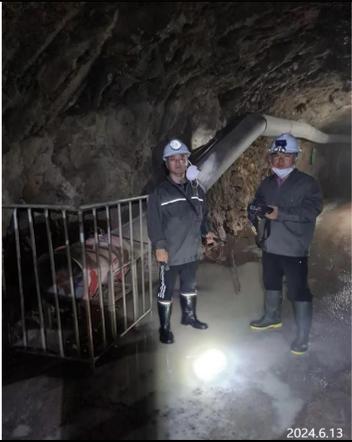
59	GX-B1594/21-9-24068	2024. 7. 25	除风量、风压不判定外，其余所检项目合格。

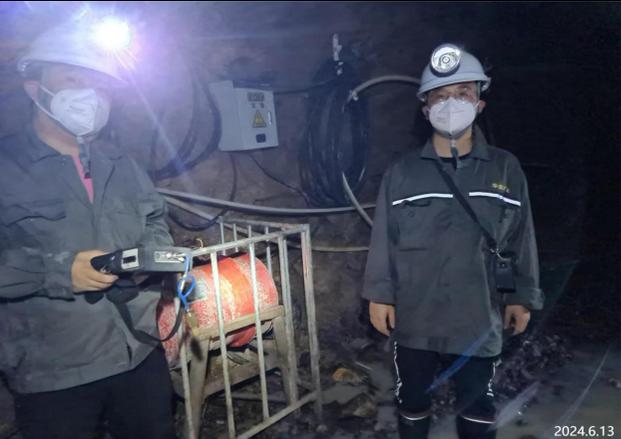
A photograph showing two workers in a dark tunnel. They are wearing hard hats and safety gear. One worker is holding a device, possibly a detector or measuring instrument. The tunnel walls are rocky and uneven. A date stamp '2024.6.13' is visible in the bottom right corner of the image.
60	GX-B1594/21-9-24069	2024. 7. 25	除风量、风压不判定外，其余所检项目合格。

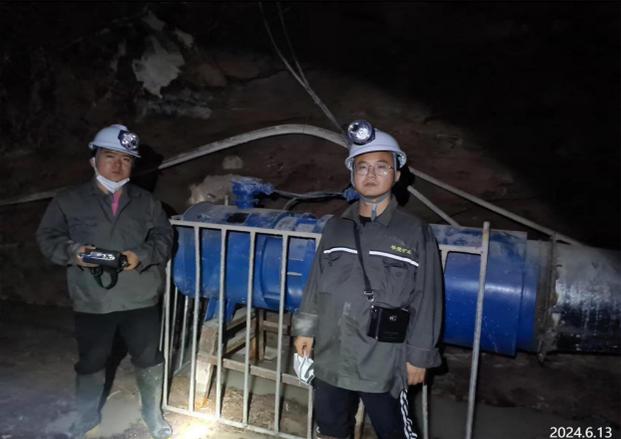
61	GX-B1594/21-9-24070	2024. 7. 25	除风量、风压不判定外，其余所检项目合格。
