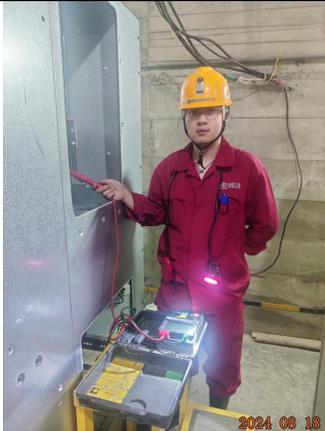
序号	报告编号	发布日期	结论	影像资料
63	GX-B1336/22-6-24003	2024/9/14	所检项目合格。

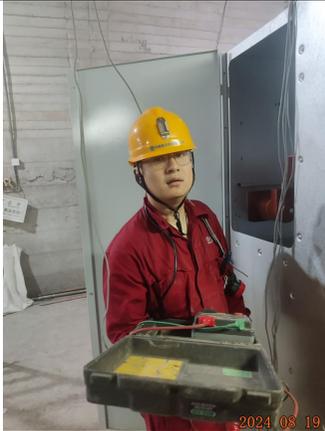
A worker in a red uniform and yellow helmet is performing an inspection on a metal cabinet. The worker is holding a red tool and pointing at the cabinet. A yellow toolbox is on the floor next to the worker. The date stamp in the bottom right corner of the image is 2024 08 18.
64	GX-B1336/22-6-24004	2024/9/14	所检项目合格。

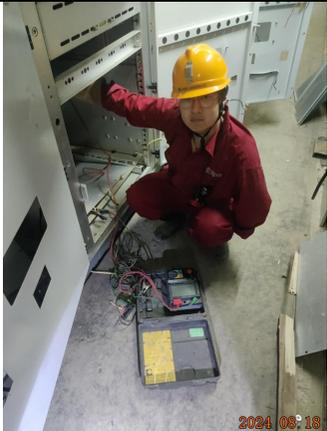
65	GX-B1337/22-6-24001~24037	2024/9/14	本次共检电流互感器37只，37只所检项目合格。

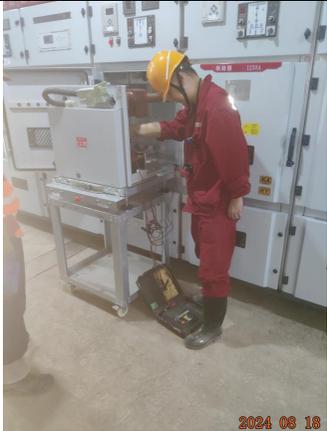
66	GX-B1337/22-6-24038~24039	2024/9/14	本次共检电压互感器2只，2只所检项目合格。

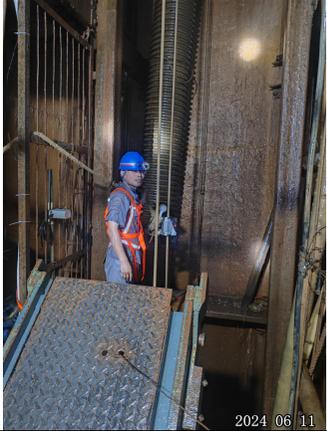
67	GX-B1598/24-6-24117	2024/9/18	实测钢丝绳有效截面积损失百分比最大为0.31%，小于5%为正常。

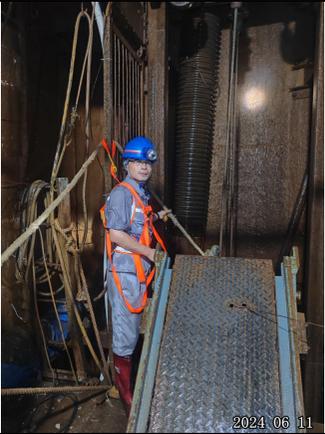
68	GX-B1598/24-6-24118	2024/9/18	实测钢丝绳有效截面积损失百分比最大为0.31%，小于5%为正常。

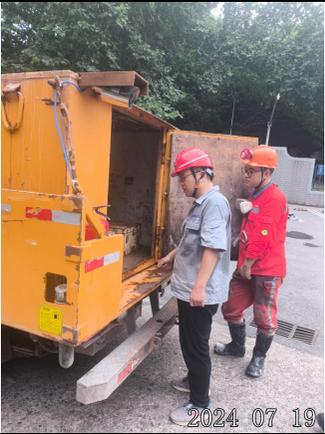
<p>2024.06.11</p>
69	GX-B1611/23-6-24004	2024/9/19	所检项目合格

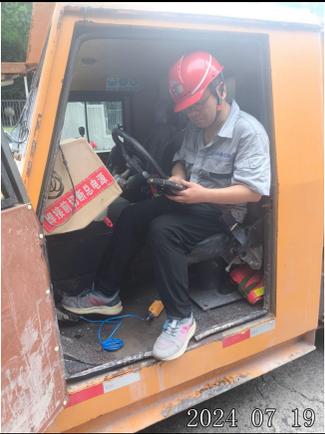
<p>2024.07.19</p>
70	GX-B1611/23-6-24005	2024/9/19	所检项目合格

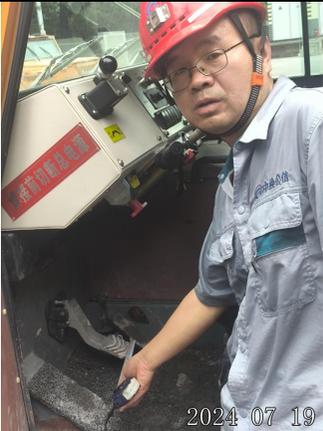
71	GX-B1611/23-6-24006	2024/9/19	所检项目合格

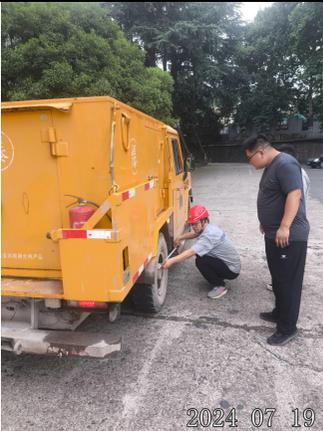
<p>2024 07 19</p>
72	GX-B1611/23-6-24007	2024/9/19	所检项目合格

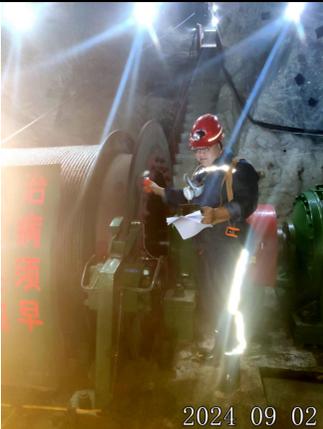
<p>2024 07 19</p>
73	GX-B1303/21-6-24030	2024/9/21	综合判定：合格。

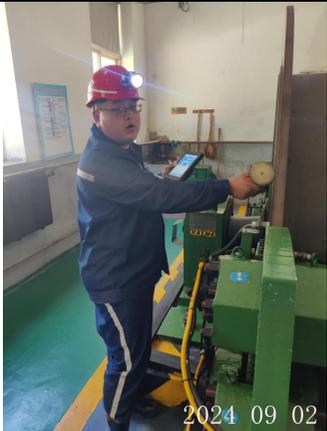
74	GX-B1303/21-6-24031	2024/9/21	综合判定：合格。

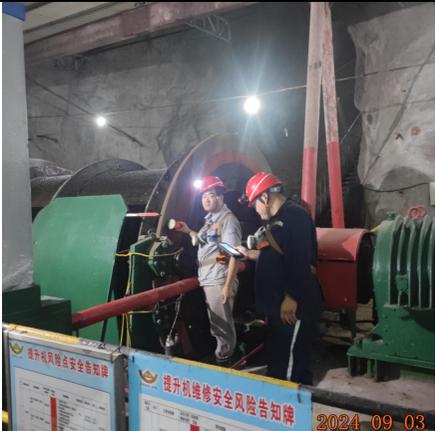
<p>2024 09 02</p>
75	GX-B1303/21-6-24032	2024/9/21	综合判定：合格。

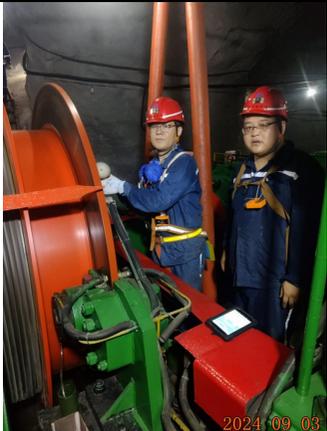
<p>提升机检修安全风险告知牌 2024 09 03</p>
76	GX-B1303/21-6-24033	2024/9/21	综合判定：合格。

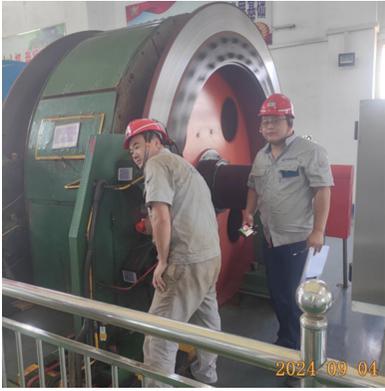
77	GX-B1304/21-6-24035	2024/9/21	综合判定：合格。

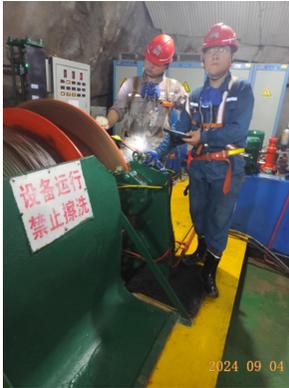
78	GX-B1305/21-6-24023	2024/9/21	综合判定：合格。

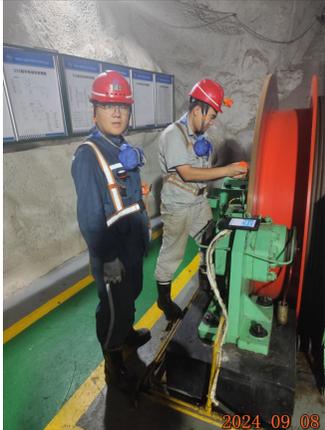
79	GX-B1303/21-6-24034	2024/9/21	综合判定：合格。

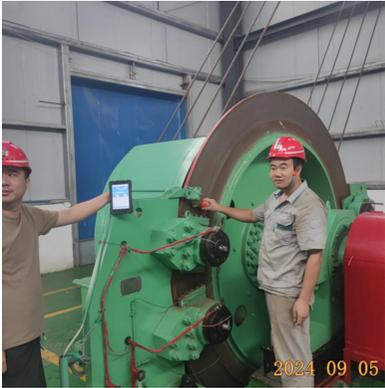
80	GX-B1304/21-6-24036	2024/9/21	综合判定：合格。

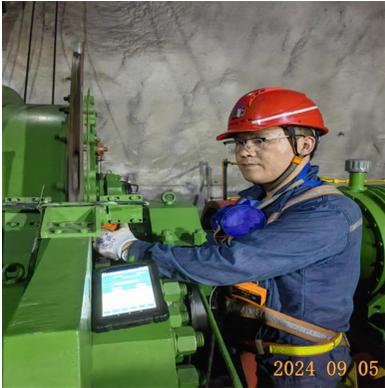
81	GX-B1304/21-6-24037	2024/9/21	综合判定：合格。

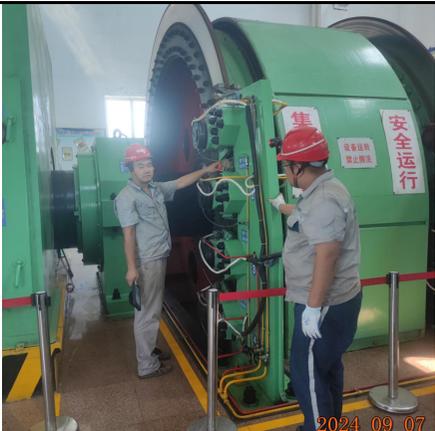
82	GX-B1304/21-6-24038	2024/9/21	综合判定：合格。

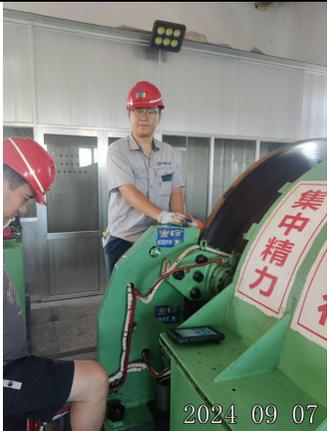
83	GX-B1304/21-6-24039	2024/9/21	综合判定：合格。

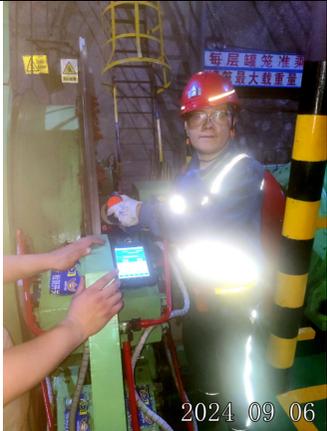
84	GX-B1304/21-6-24040	2024/9/20	综合判定：合格。

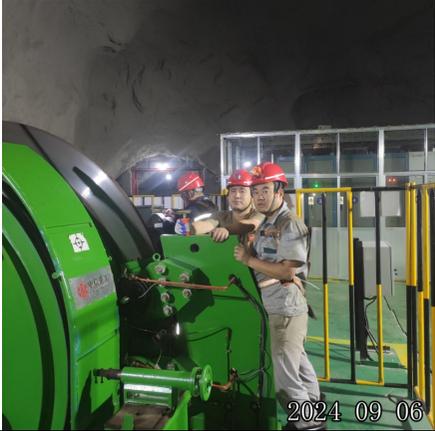
85	GX-B1304/21-6-24041	2024/9/20	综合判定：合格。

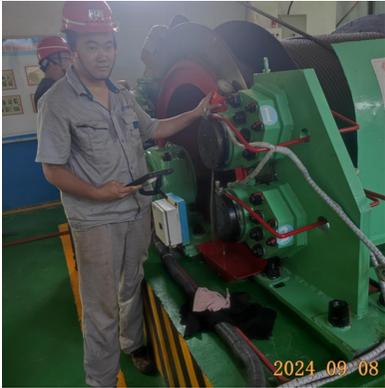
86	GX-B1305/21-6-24024	2024/9/21	综合判定：合格。
