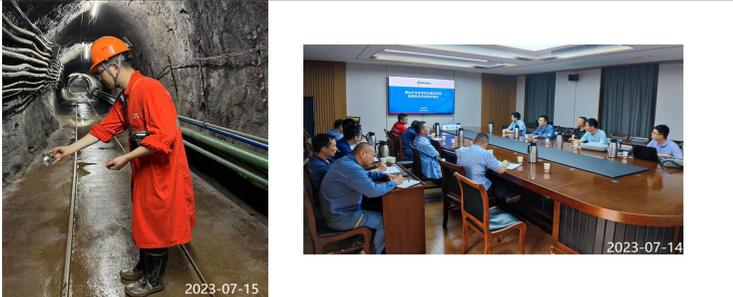
序号	报告编号	发布日期	结论	影像资料
66	GX-B1343/21-8-23015	2023. 7. 25	东区通风系统2019.8Pa；西区通风系统2302.1Pa。

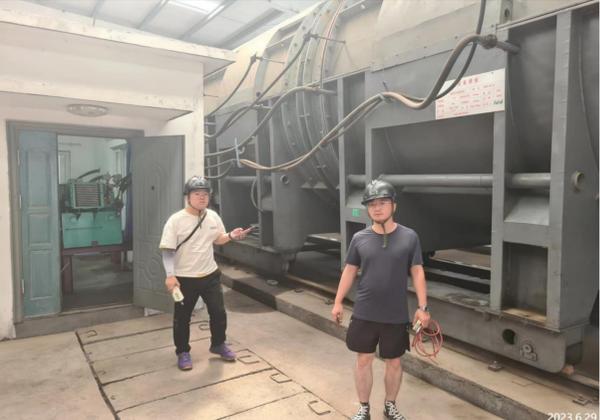
69	GX-B1340/21-8-23068	2023. 7. 28	<p>该通风机在叶片角度+6° /+6°、双级运行条件下，共测试1个运行频率状态（35Hz），依据AQ1011-2005《煤矿在用主通风机系统安全检测检验规范》进行检验，该通风机合格。</p>

A photograph showing two workers in safety gear (hard hats, safety glasses, and work clothes) standing in a large industrial facility. They are positioned in front of a large, complex piece of machinery, which is a fan. The worker on the left is gesturing towards the machine. The worker on the right is holding a red tool or cable. The date '2023.6.29' is visible in the bottom right corner of the image.
70	GX-B1340/21-8-23069	2023. 7. 28	<p>该通风机在叶片角度+6° /+6°、双级运行条件下，共测试1个运行频率状态（35Hz），依据AQ1011-2005《煤矿在用主通风机系统安全检测检验规范》进行检验，该通风机合格。</p>

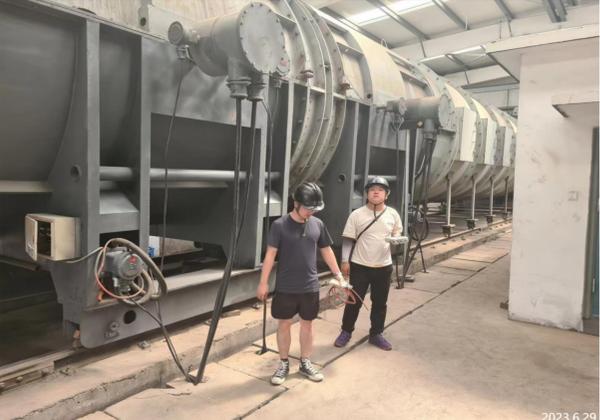
A photograph showing two workers in safety gear (hard hats, safety glasses, and work clothes) standing in a large industrial facility. They are positioned in front of a large, complex piece of machinery, which is a fan. The worker on the left is holding a red tool or cable. The worker on the right is gesturing towards the machine. The date '2023.6.29' is visible in the bottom right corner of the image.
